## **Mount Laura Conservation Reserve Works August 2009 to May 2010.**

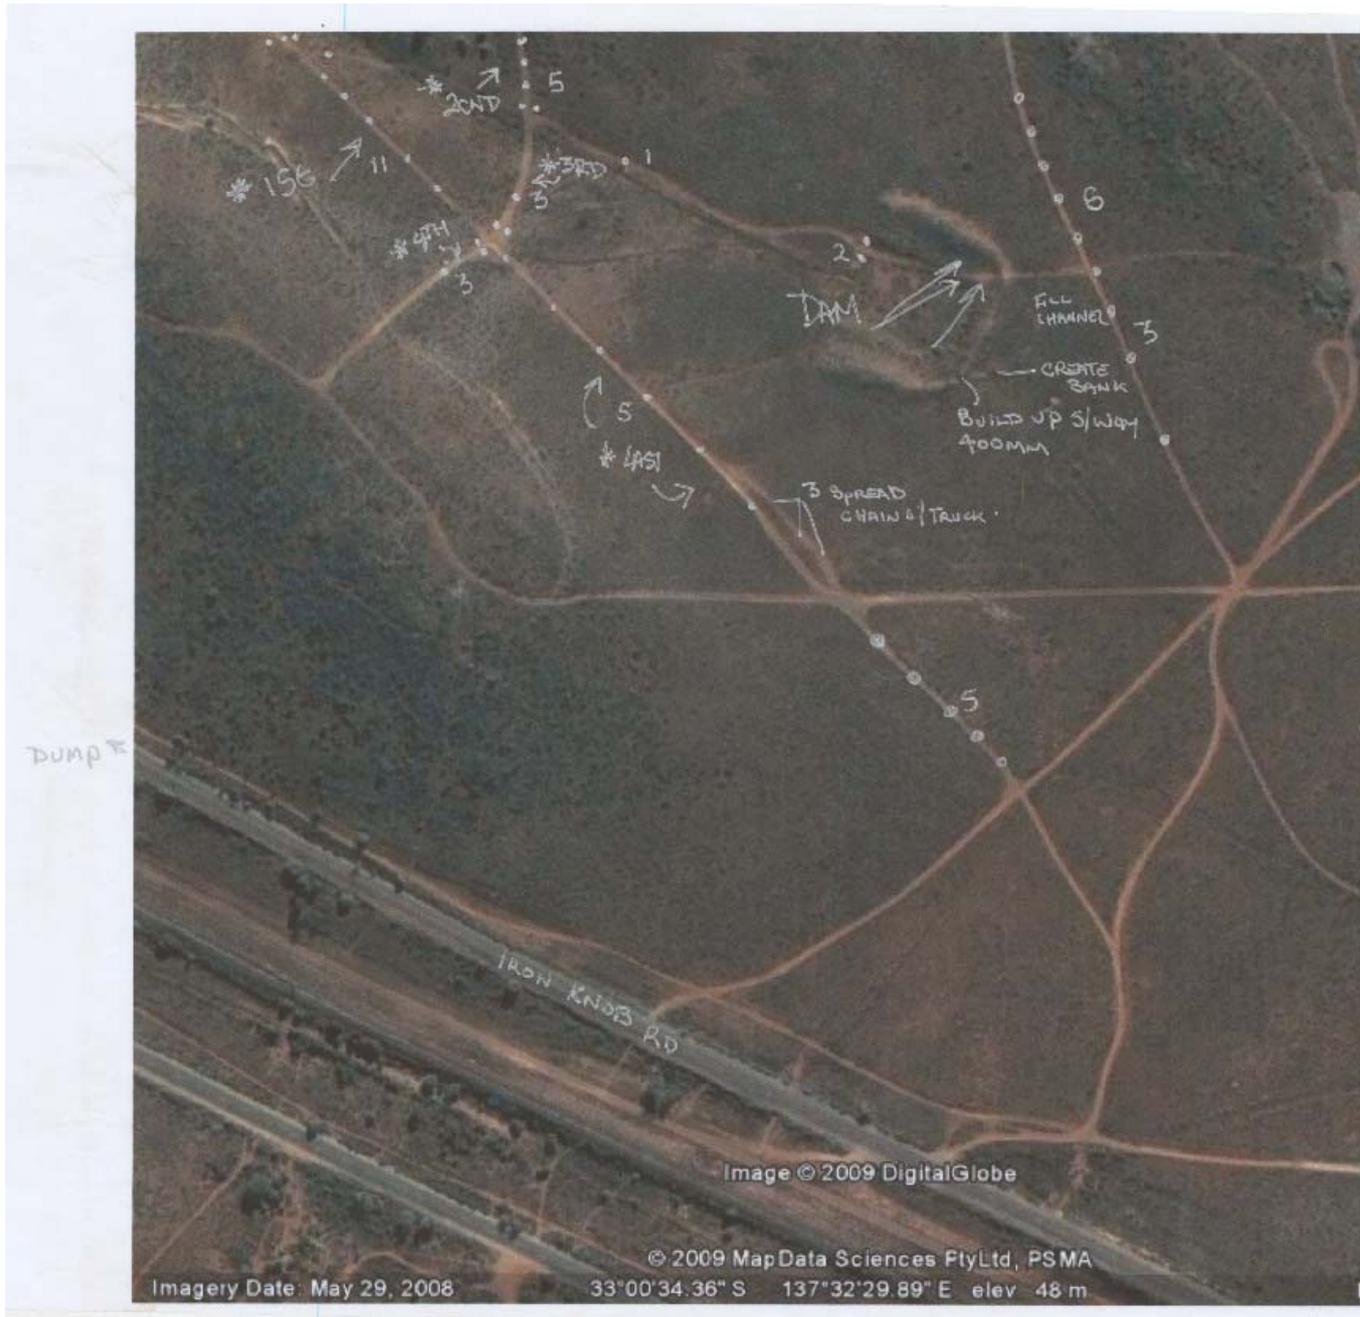
Above is a map of the area we developed to stop water rushing down established 4WD tracks, washing them out as they go. This map shows where rock piles are strategically dumped to reduce flow velocity of water down the tracks (that are acting as drains), and redirecting it back down the slope as it once did before the establishment of the tracks.

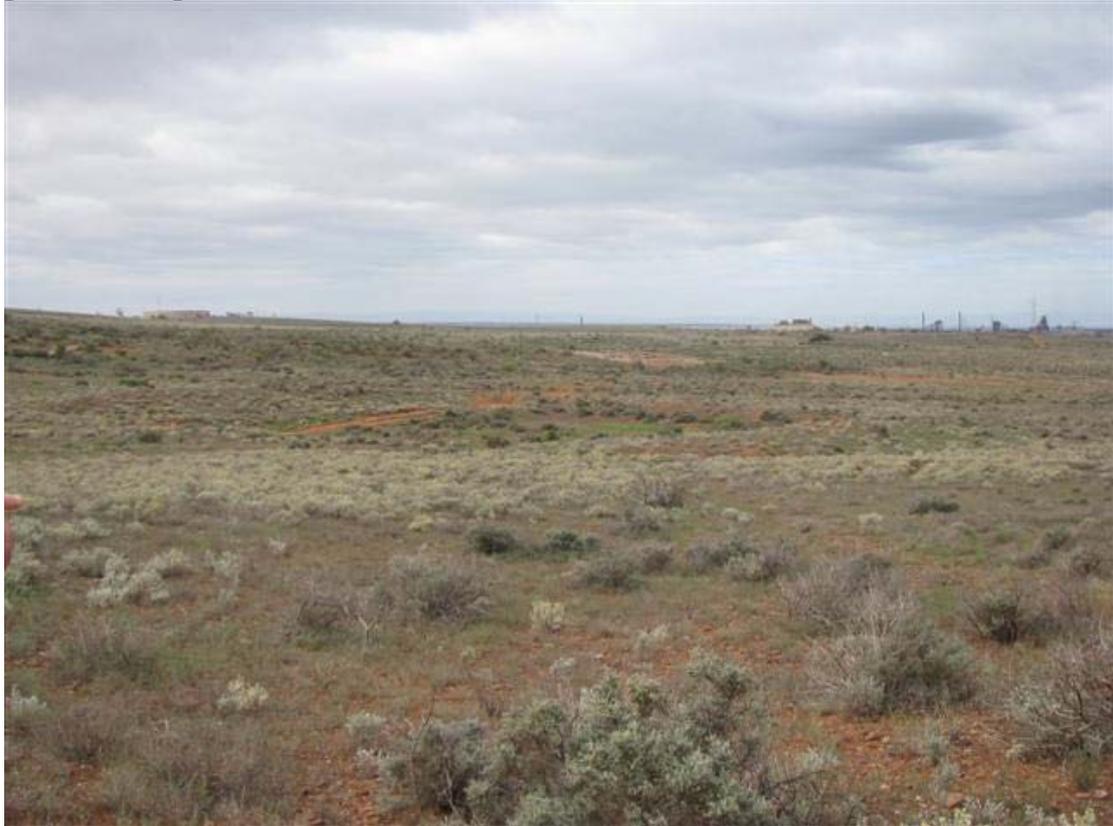
The above picture shows the old BHP storage dam.

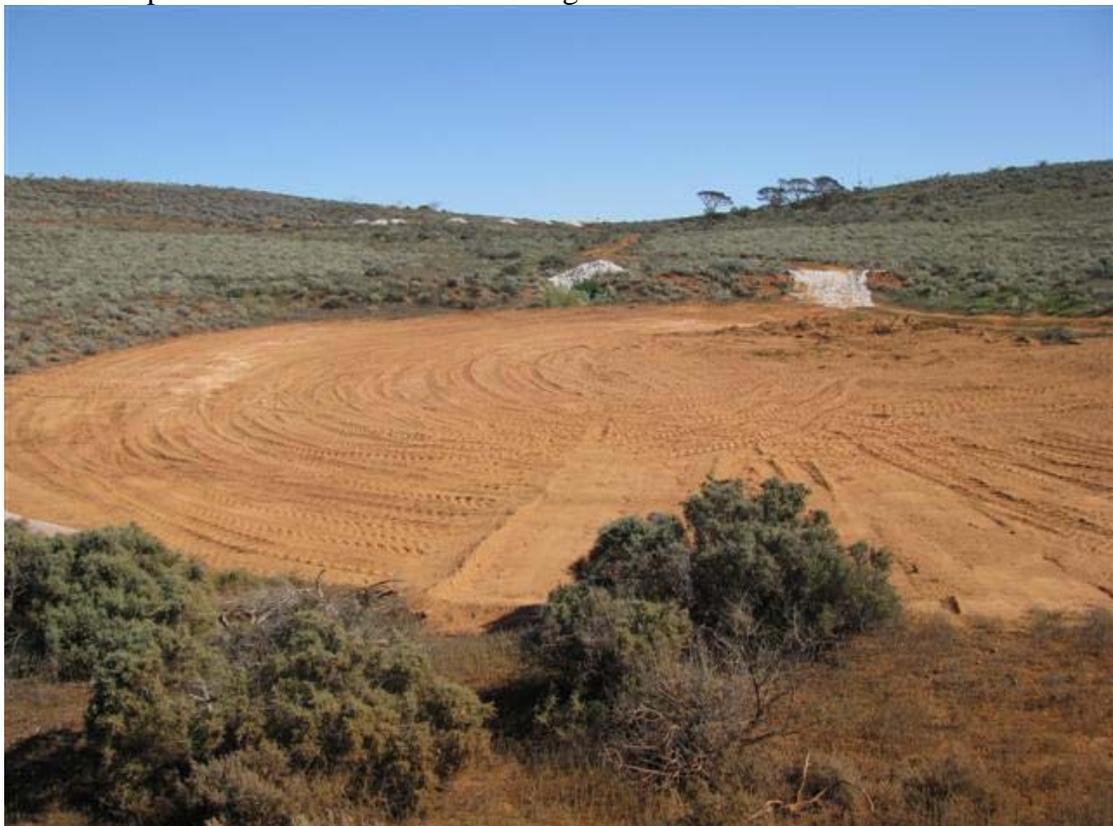
The above picture shows the same dam cleaned out, with armoured spillways leading into and out of it.

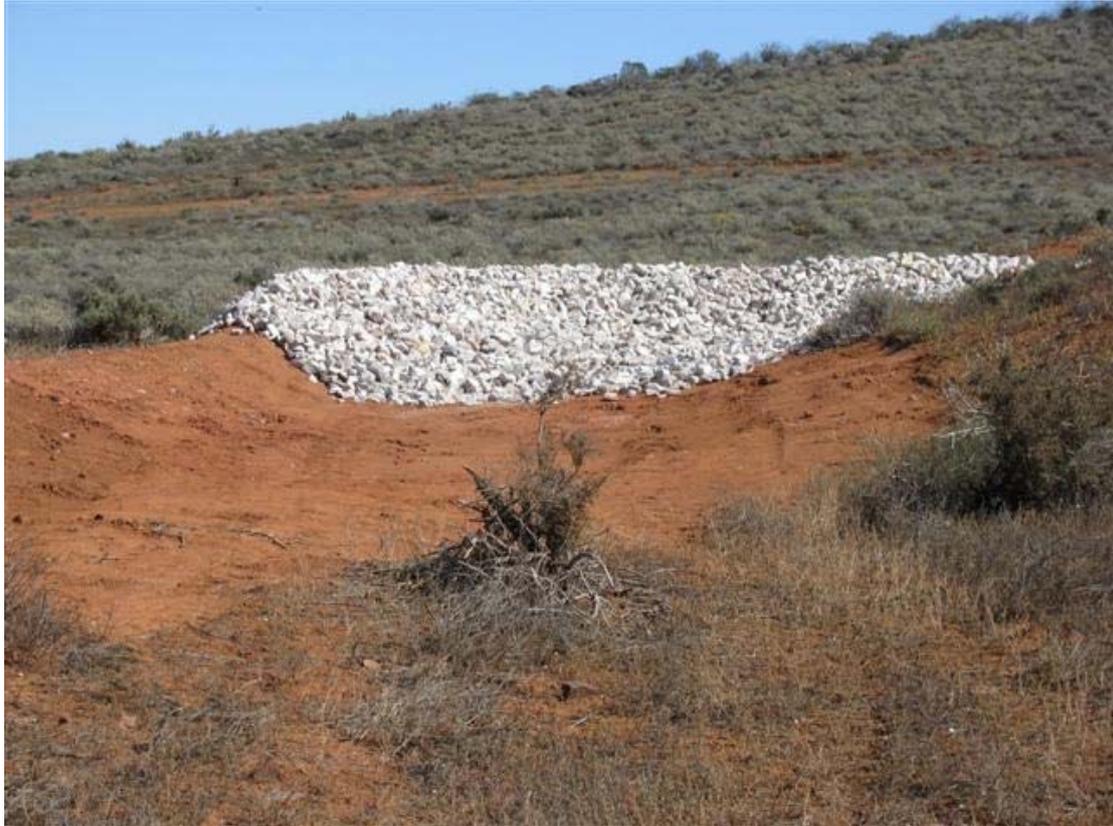
The picture above shows the Dams new armoured spill way.

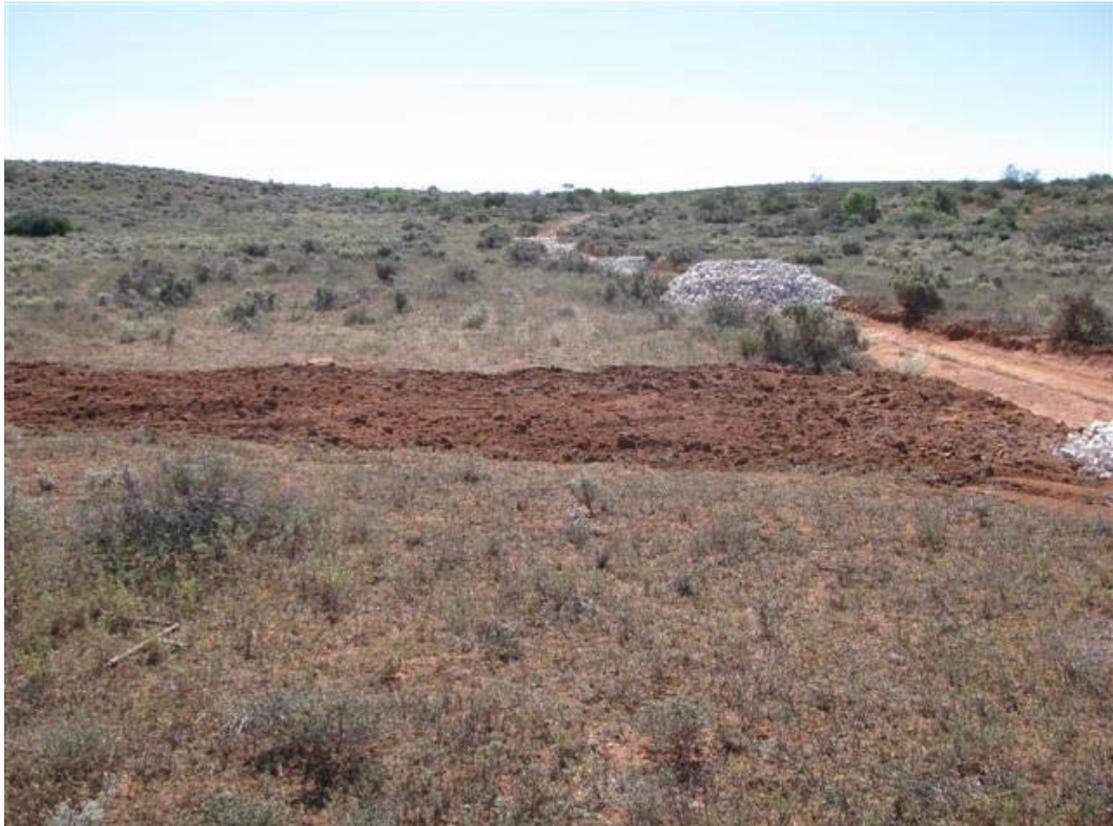
Picture above shows the 4WD track that used to run into the dam, ripped.

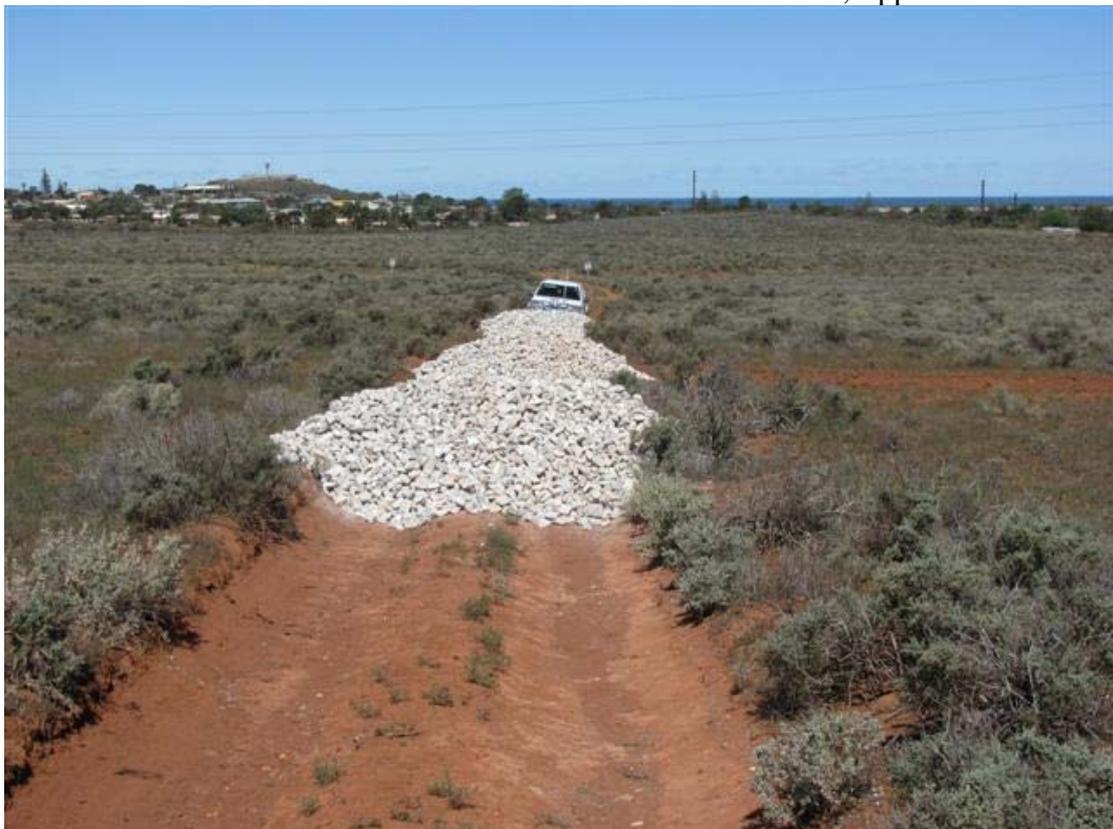
Picture above shows water that used to run down this track, which acts as a drain during heavy rainfall, will now pond behind these piles of ballast, and finally 'bleed out' into the surrounding vegetation.

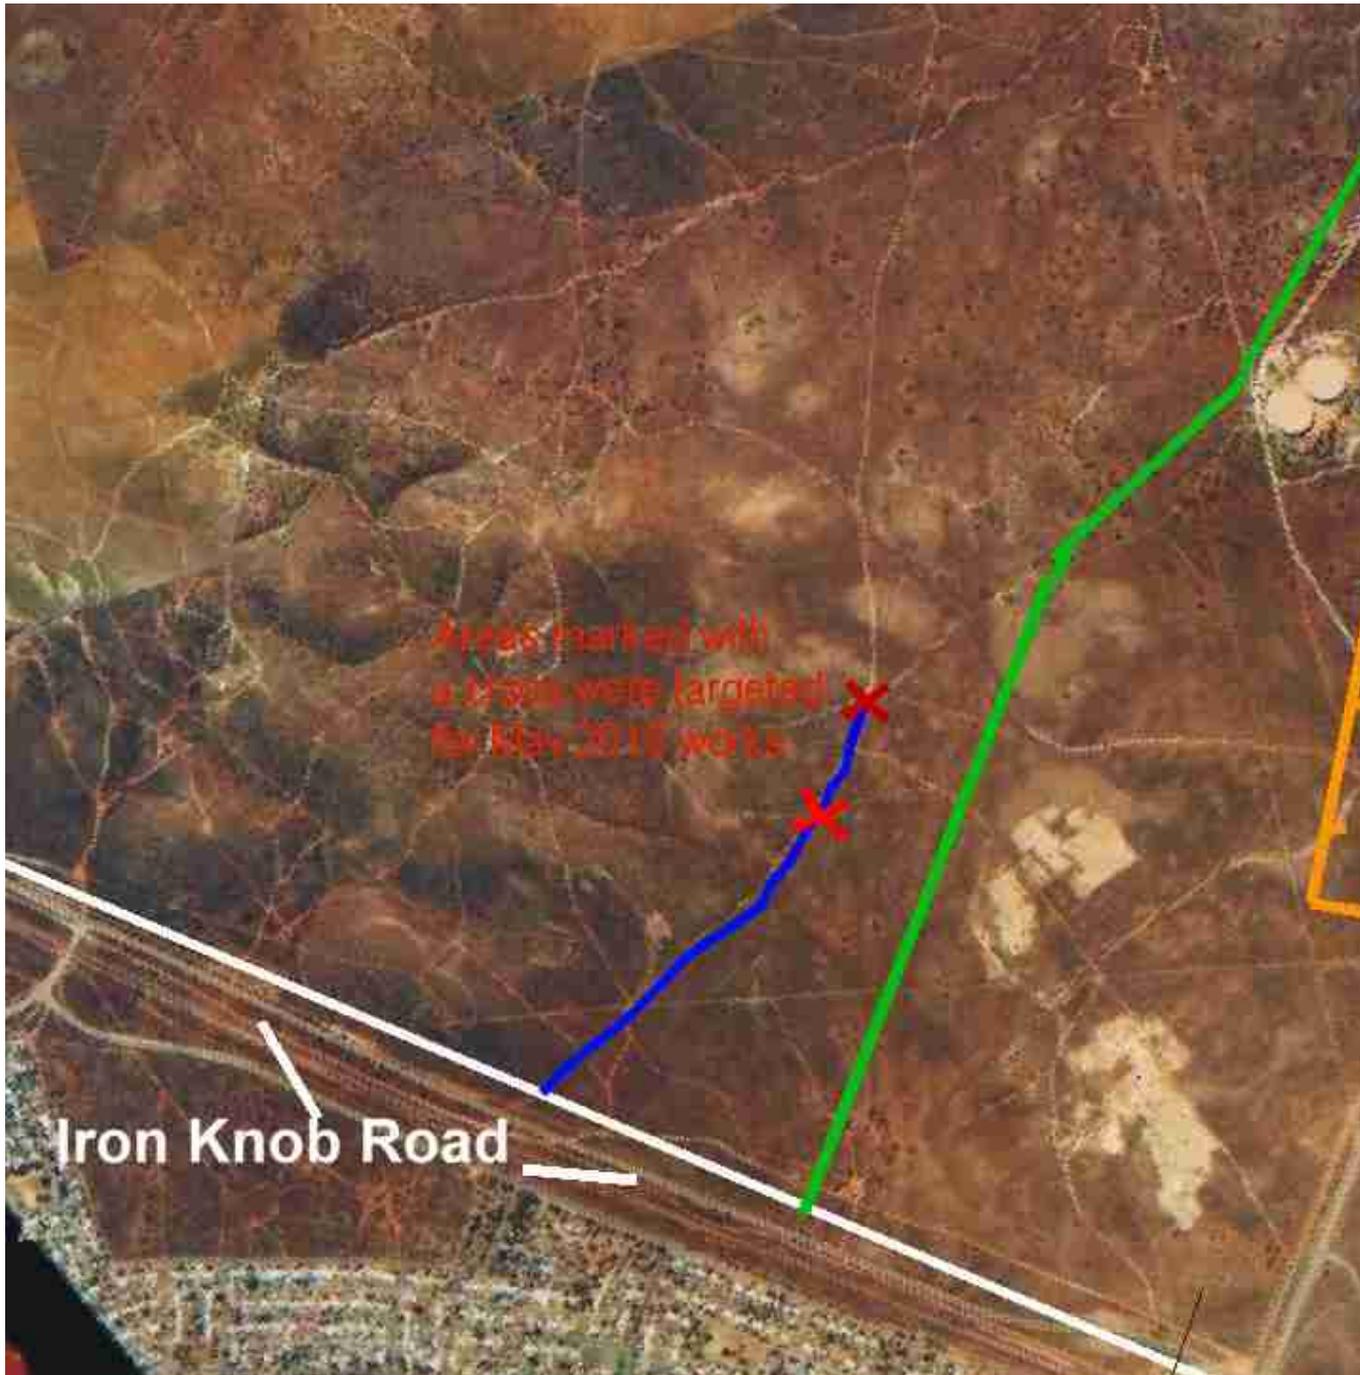
Photo above shows where the works were concentrated in May 2010. Sites are marked with a cross.

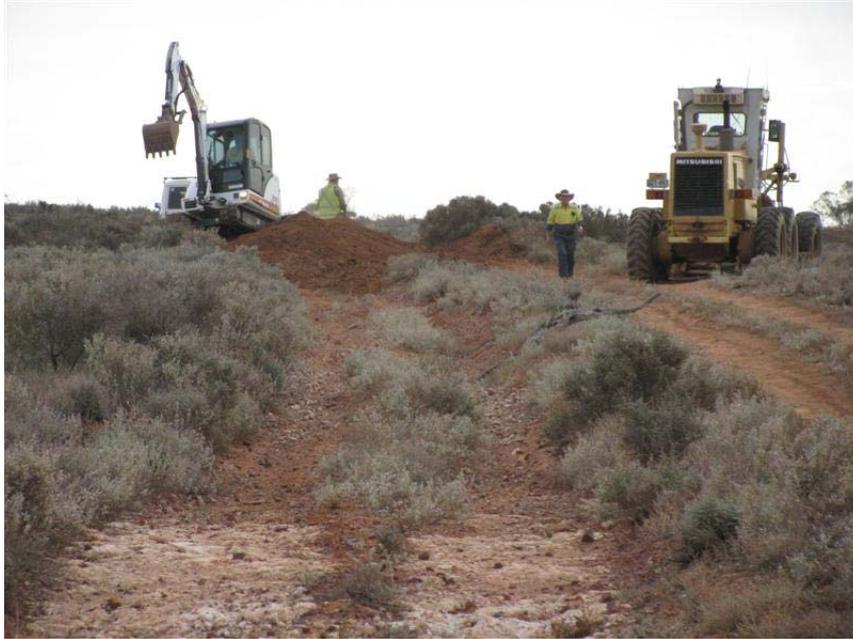
The photo above shows the first section of track that needs attention. Because it's so badly eroded, people have stopped using this track, and made a new one next to it. Unfortunately, this situation is repeated all too often in the Conservation reserve.

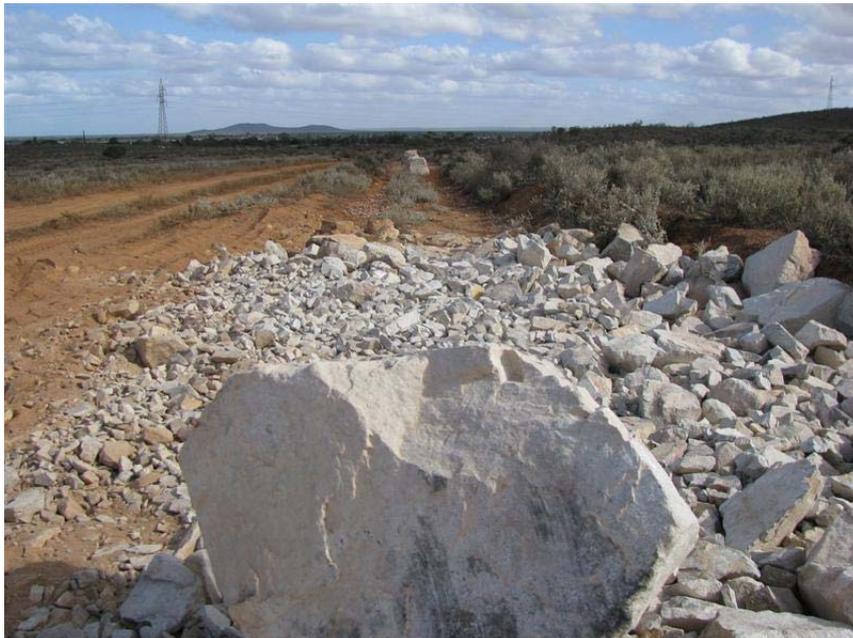
Above is the same section of track, after rehabilitation. Rocks have been strategically placed to stop any further use of this track, confining authorised users to the new track.

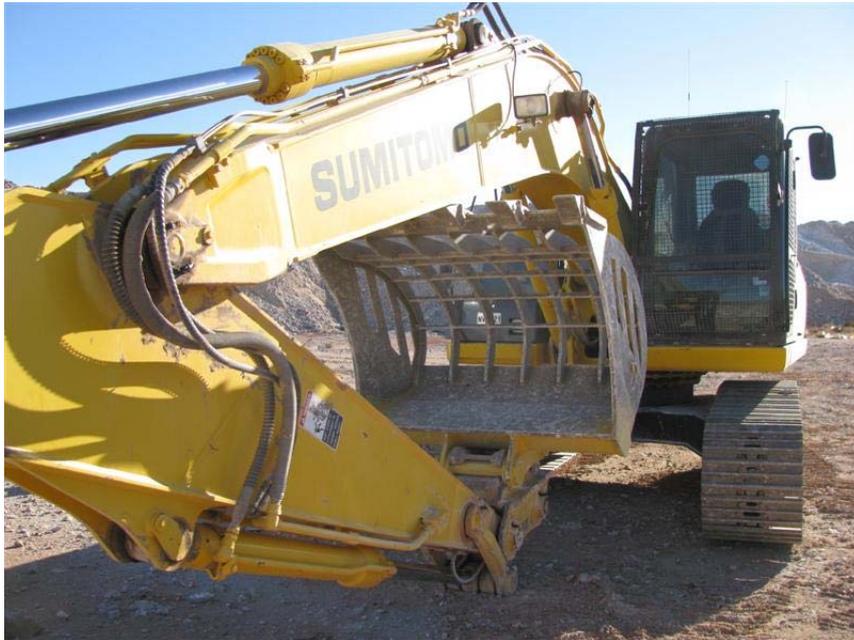
Above is a picture of an excavator with a rock screening bucket attached. The work of this excavator was essential to provide us with graded 400mm – 700mm rock that's required for the erosion control work. This rock will from now on be referred to as 'Rip Rap'.

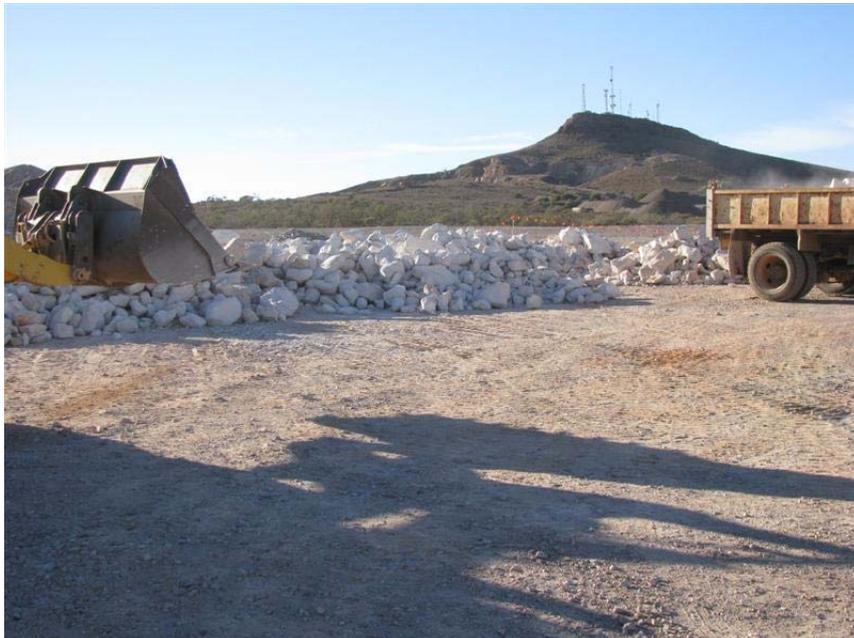
The above picture shows the piles of rip rap ready for loading to be transported to the work site.

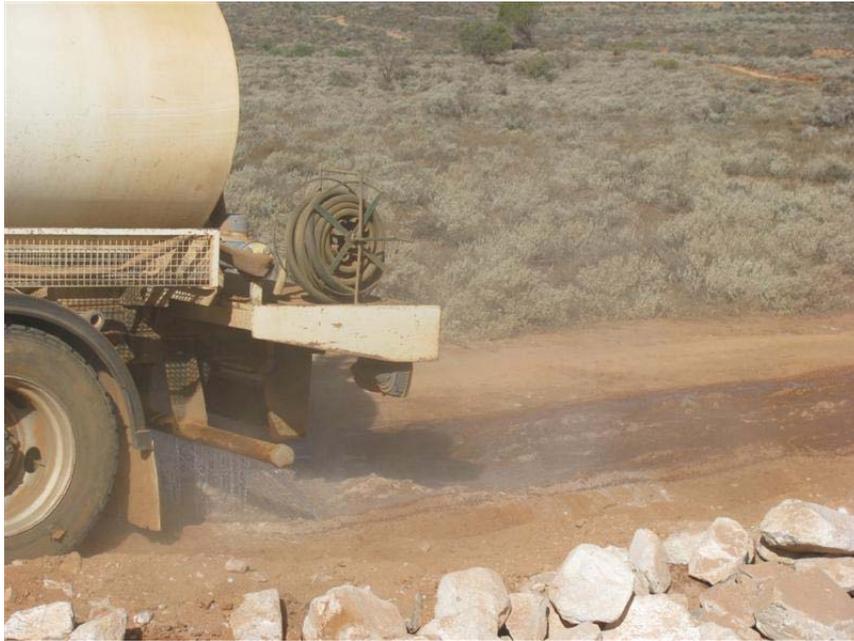
This was dusty work. With the help of Council's water truck, we were able to control dust levels, as well as compact the soil in the tracks as we drove over them, leaving them less prone to future erosion.

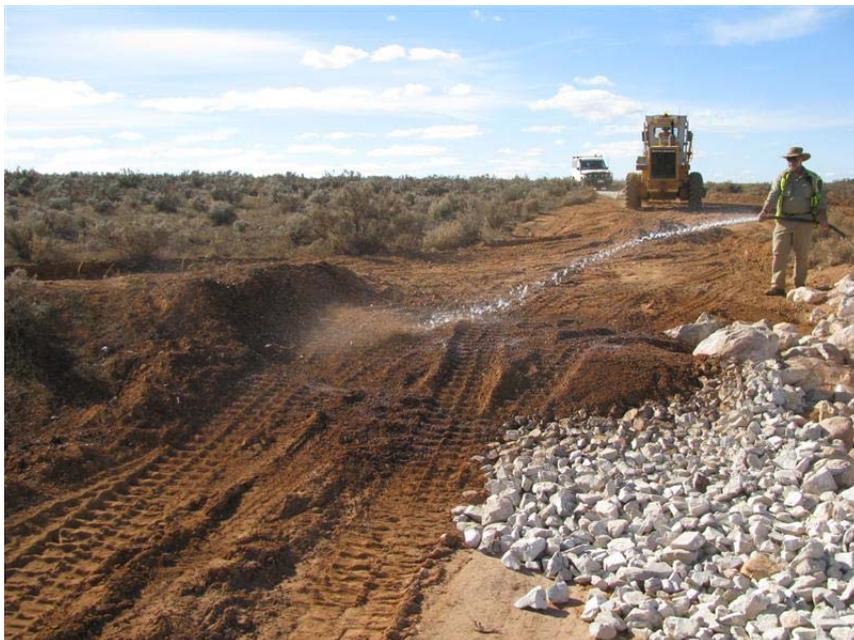
The above picture shows how important water is in preparing this dirt mound for compaction, before it was covered in A34 geotextile, and a final layer of ballast (40mm – 60mm) rock. This procedure ensures a permanent solution to the above erosion issue, leaving us free to move on to the next problem area when works are next scheduled to occur.

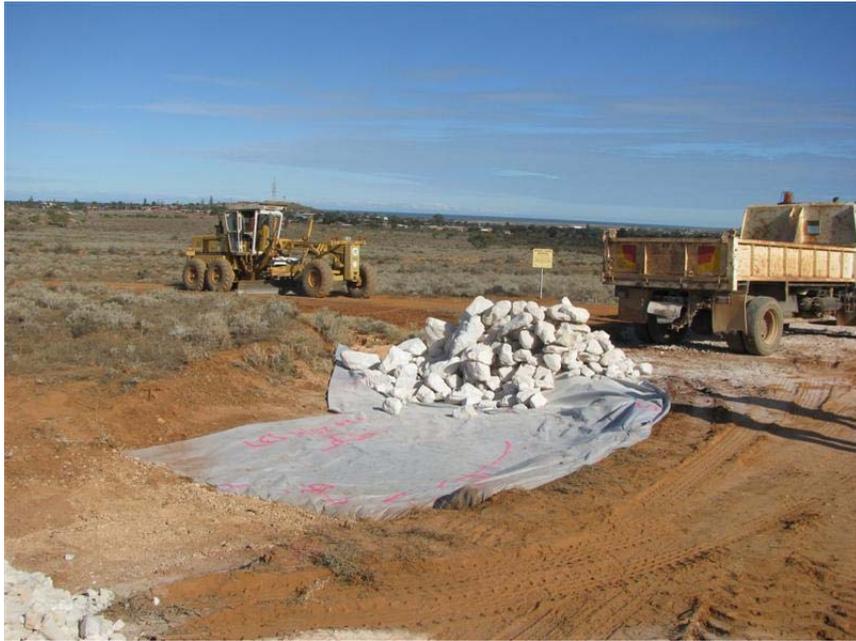
Pictured above is a drain being armoured with geotextile and rip rap.

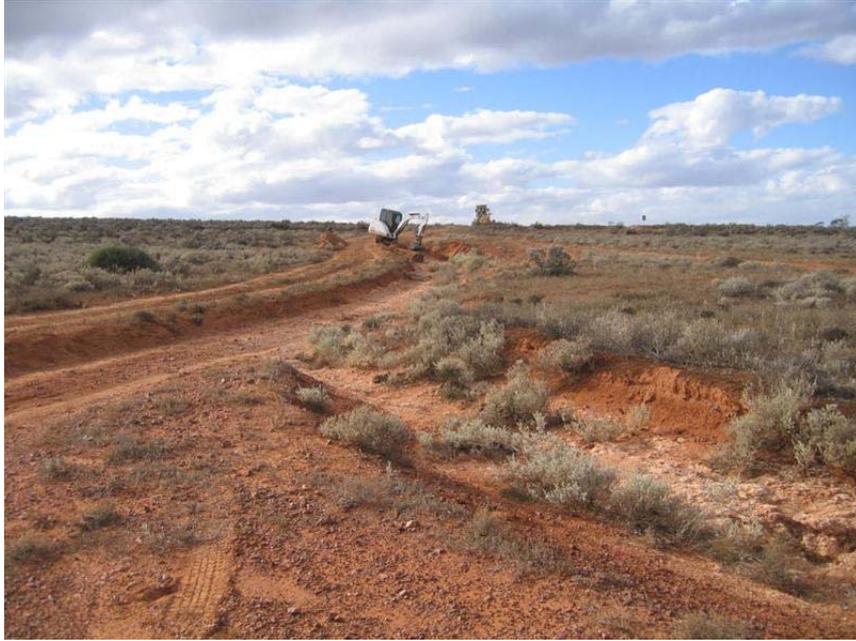
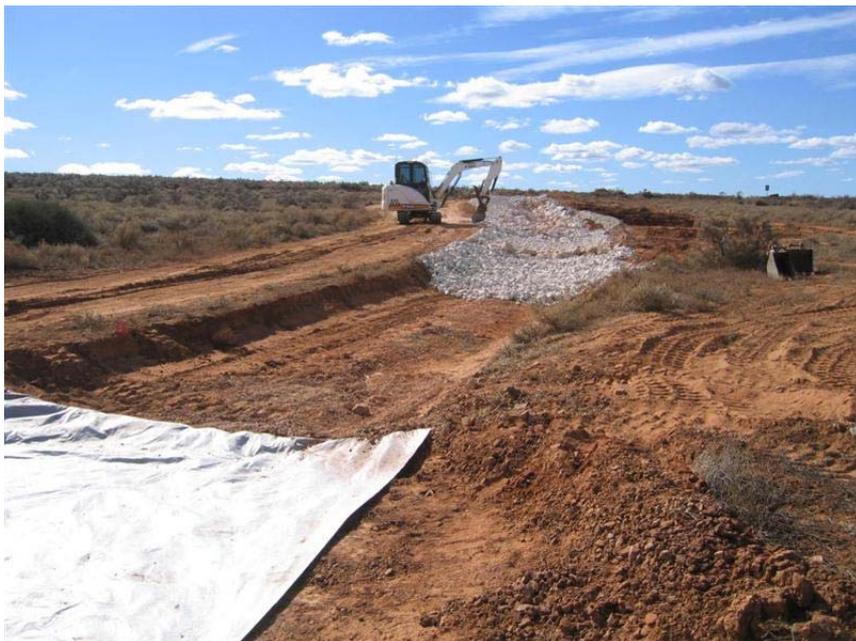
Above and below shows a before and after of the track and drain rehabilitation work. While this work can be time consuming and expensive at times, if done properly, it will provide a permanent solution to the initial problem, that will only get worse and increasingly dangerous if left untreated.
