19.1.1 Unsolicited Proposal – 127 Nicolson Avenue – **CONFIDENTIAL**

Council Meeting: 15 May 2023
Author's Title: Manager Finance **File No.:** 0-159
Directorate: Corporate Services

A – Valuation
B – Formal Counteroffer
C – Building Report

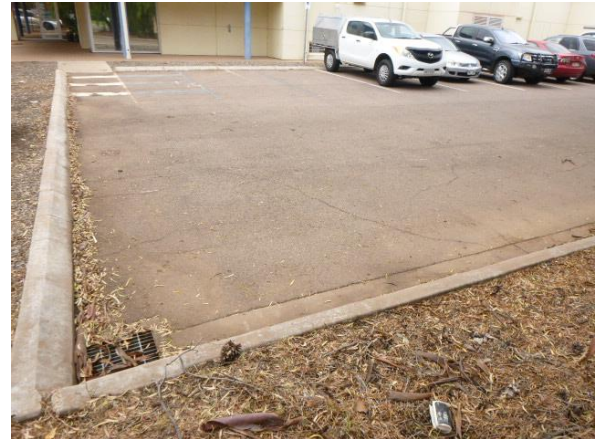
Tree and garden litter provision

Litter will enter parking area stormwater sumps.
Warrants checking that parking area sumps are clear through to the outlets and sumps are clear of litter annually

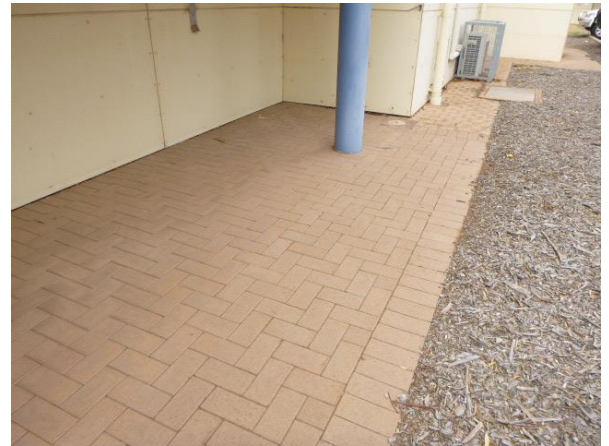
Pathways

The paths around the Building are in a serviceable condition for the age of this building with no major defects visible.

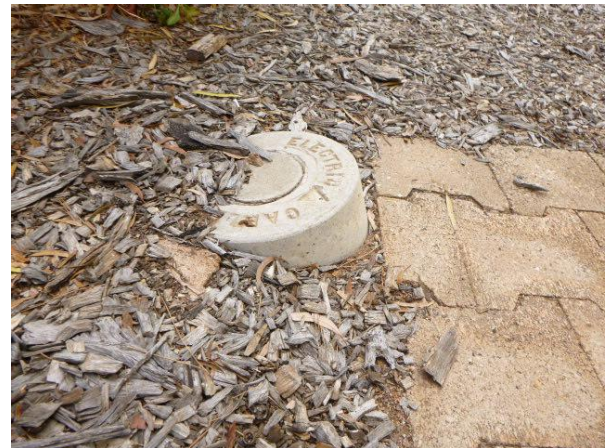
Electricity cable cover damaged

Warrants electrical safety check performed by
Licensed electrician

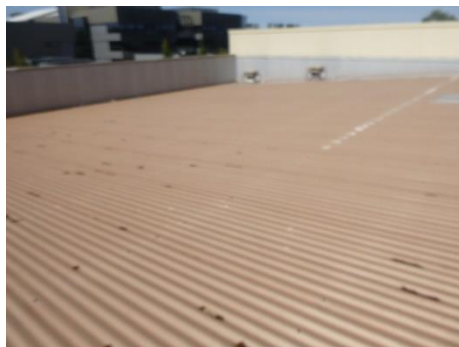
Roof Covering

Of the visible areas, the general condition of the corrugated iron roof is in serviceable condition.

There appears to have been extensive re sheeting and remedial work performed.

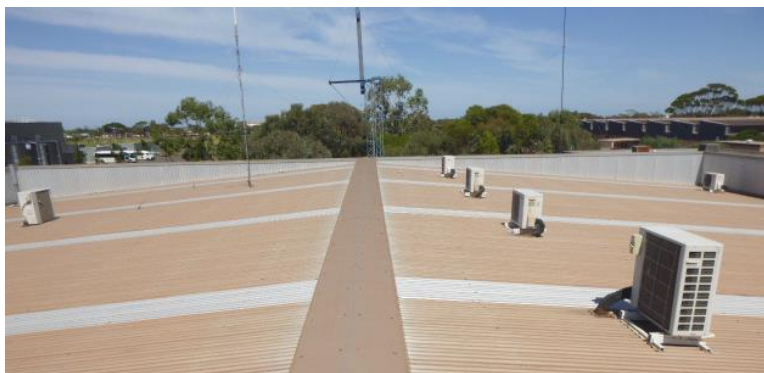
Reverse cycle air conditioners.

Satisfactory installation

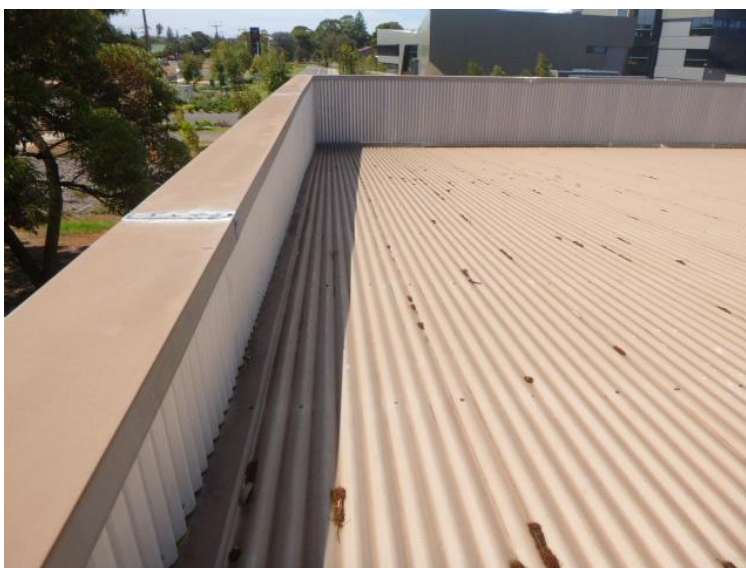
Parapet Flashings

serviceable condition

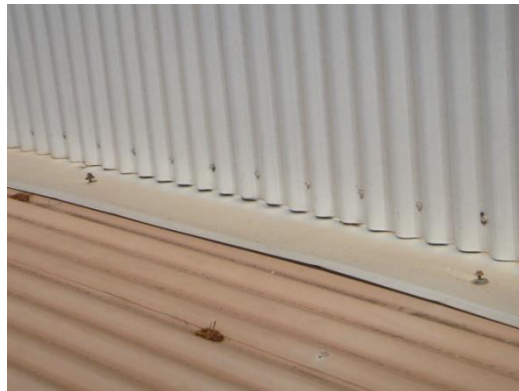
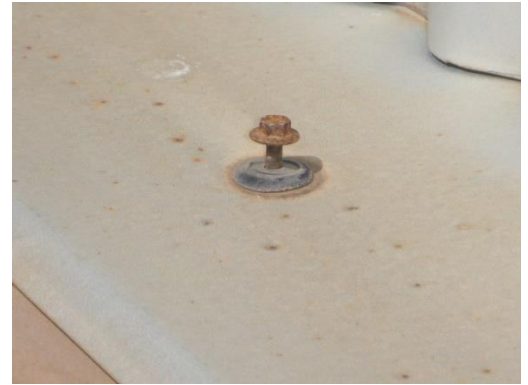
Apron flashings

Apron flashing screw fixings are loose in places allowing the apron flashing to lift in high force winds and rain water to enter.

Warrants re fixing existing screws and installing additional rivet fixings between existing screws.

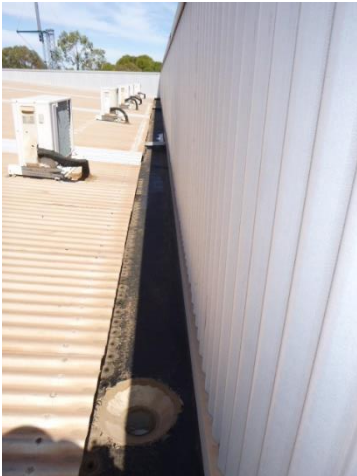
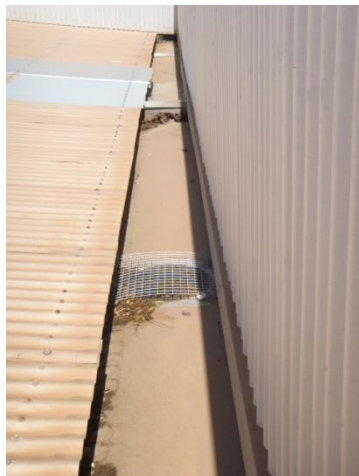
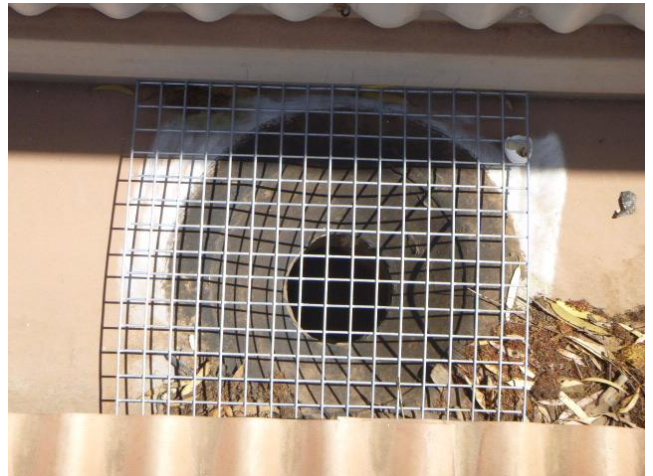
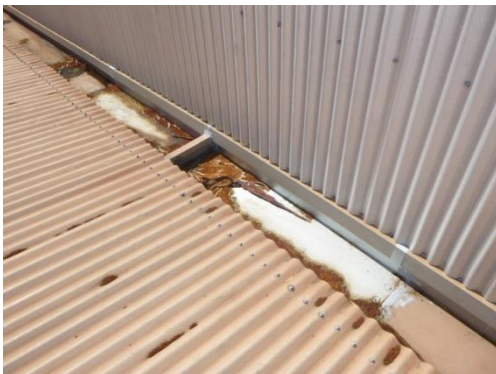
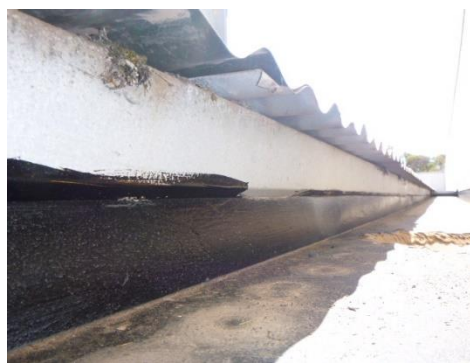
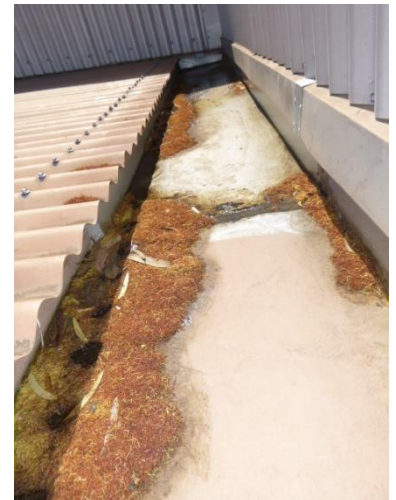
Box Gutter Findings

All the box gutters have been surface treated with a bitumen emulsion and some have been replaced.

Box gutters are in a serviceable condition

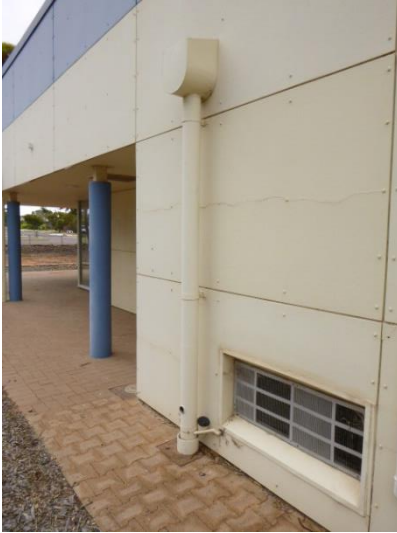
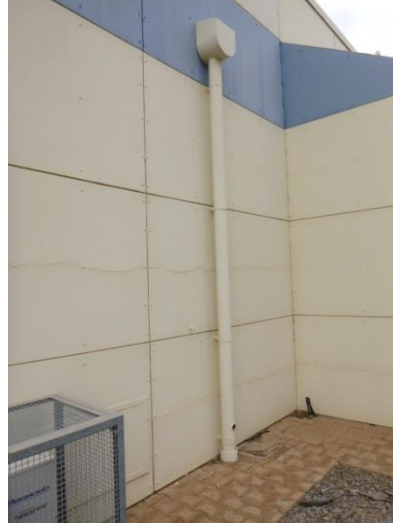
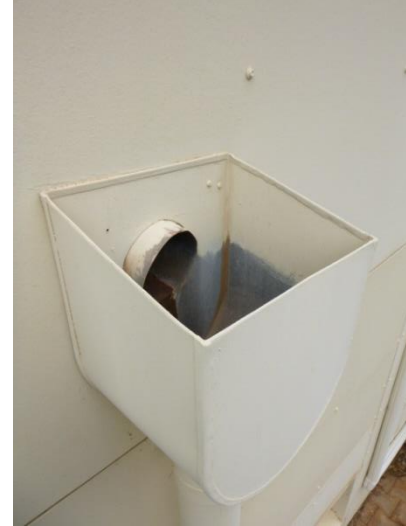
On visual inspection no apparent defects were noted to the existing down pipes and rain heads that are considered serviceable.

Rain heads have been set lower than box gutters in accord with requirements

All downpipes at their base have a port to facilitate cleaning. Normally the caps would be in place but in this case all caps have been removed.

This may be the result of metal theft or the stormwater drains blocked. Warrants having all stormwater drains connecting downpipes inspected for blockages and receiving all clear notification and plastic caps installed.

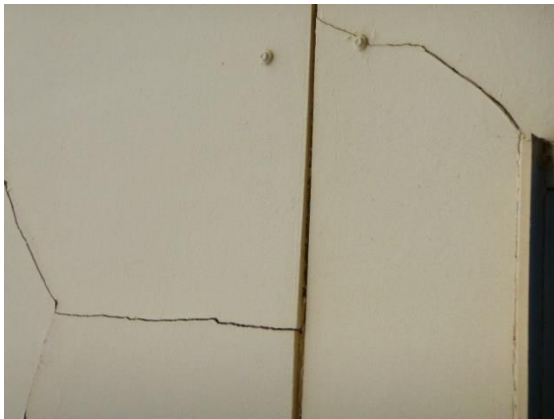
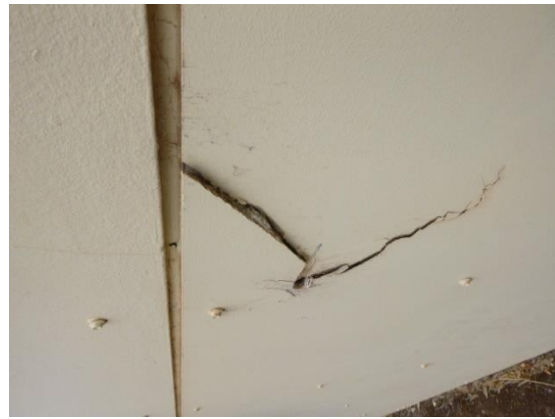
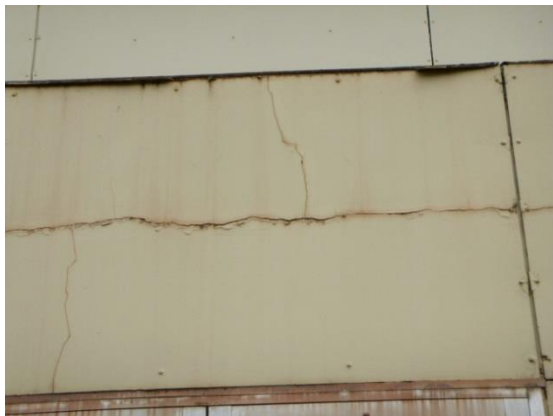
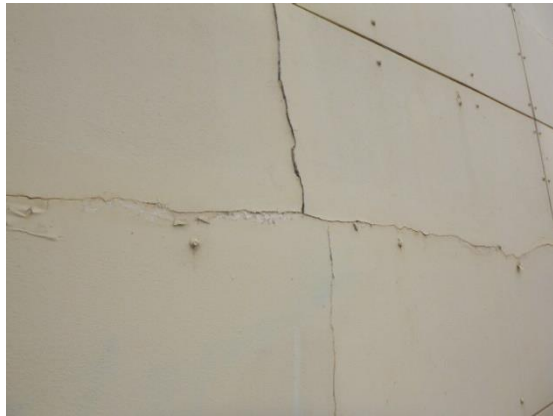
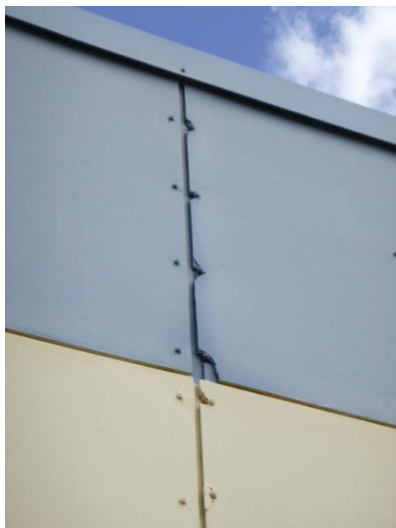
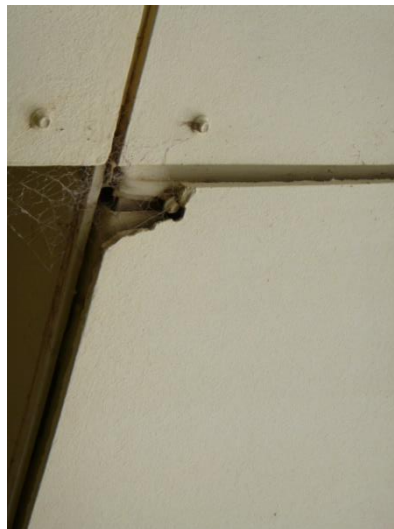
6 Exterior cladding cement sheeting panels require replacing to avoid rain water entry

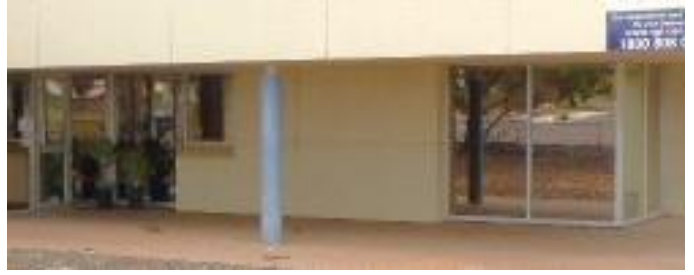
Windows

On visual inspection, the general condition of the windows are serviceable for the age.

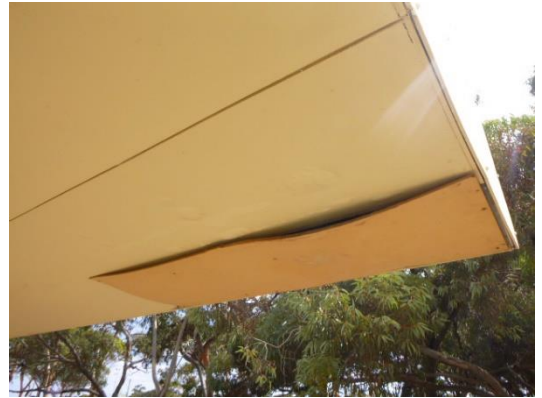
1 Soffit lining panel to the south east corner warrants replacing and provision in the replacement panel made for a plastic drain to cater for future extraordinary storm events

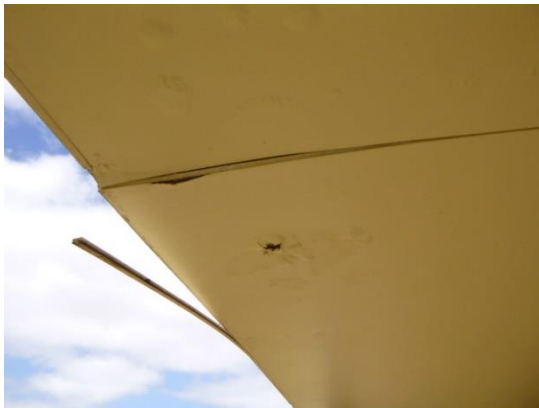
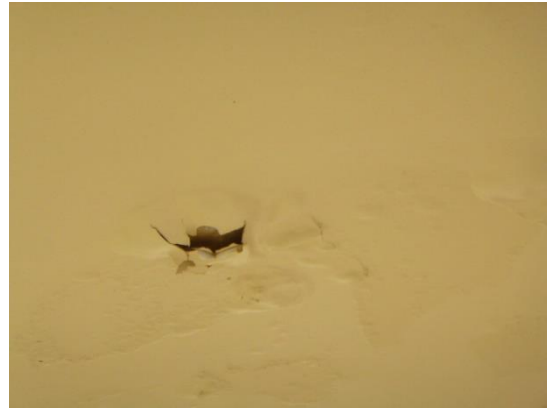
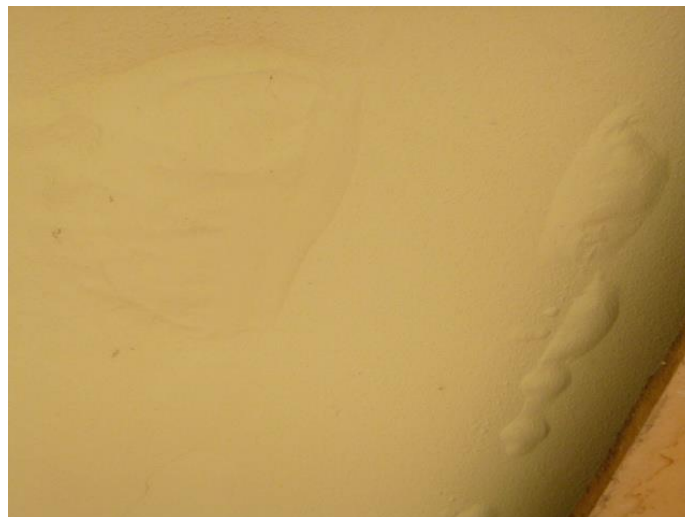
Rain water is pooling on the south east eave soffit cement sheet panels causing damage. Caused from overflowing box gutter. Warrants repairs to the cement sheeting and corner bead.

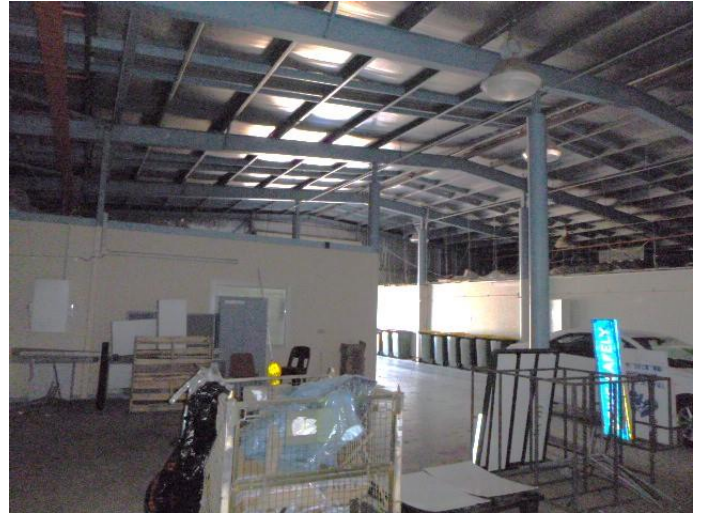
Garage and storage area

From the visible and accessible areas, this garage and storage area appears to be in a serviceable condition for the age of the property with no notable structural defects sighted.

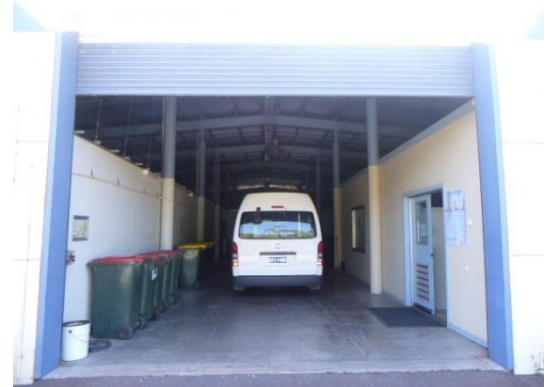
Commercial roller door

Serviceable condition

NOTE: While the roller door is kept open any energy efficiencies are lost

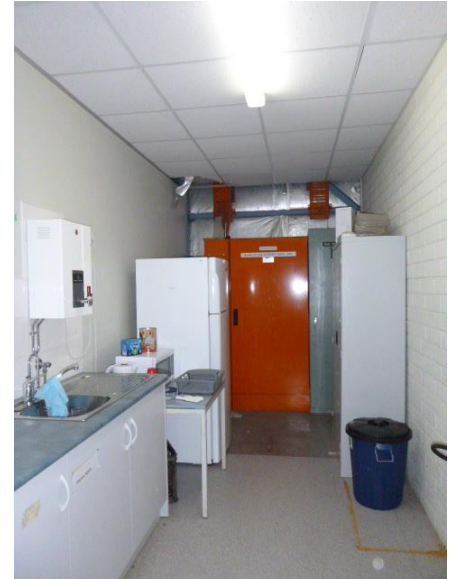
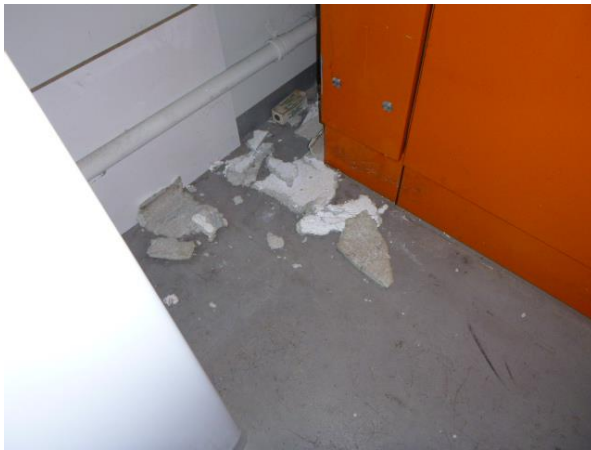
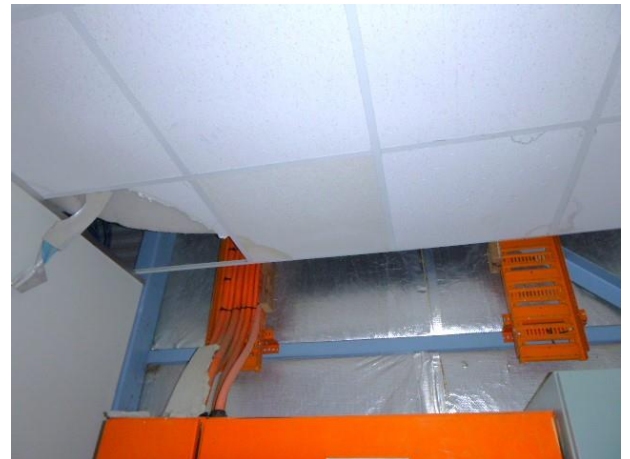
Kitchen

From the visible and accessible areas, the kitchen Hot water system, cupboards and benchtop appears to be in a serviceable condition for the age of the property.

NOTE: There is a musty smell in this room.
The ceiling tiles are damaged and wall cladding is missing.
Ceiling tiles have fallen to the floor all caused by water falling from overflowing box gutter.
Warrants ceiling tile repair and replacement of the wall lining around the electrical switch box

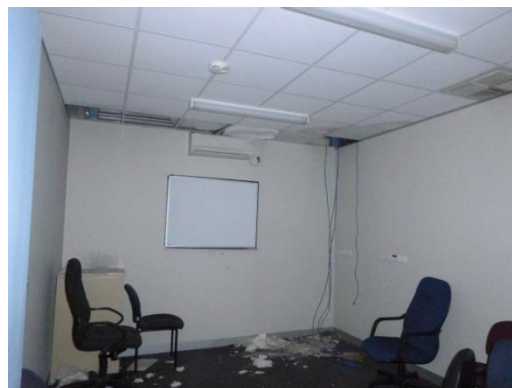
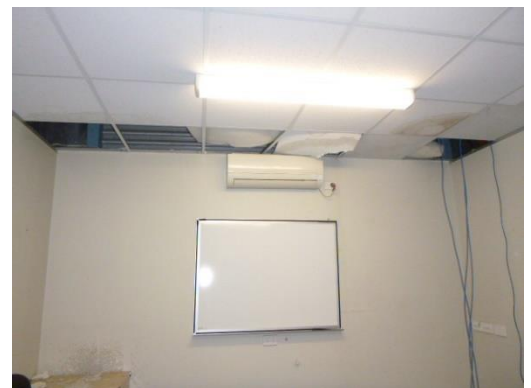
Office 1

From the visible and accessible areas, this area and wall mounted air conditioner appears to be in a serviceable condition for the age of the property.

There is water damage to 9 ceiling tiles along the north wall that warrant replacing caused from overflowing box gutter.

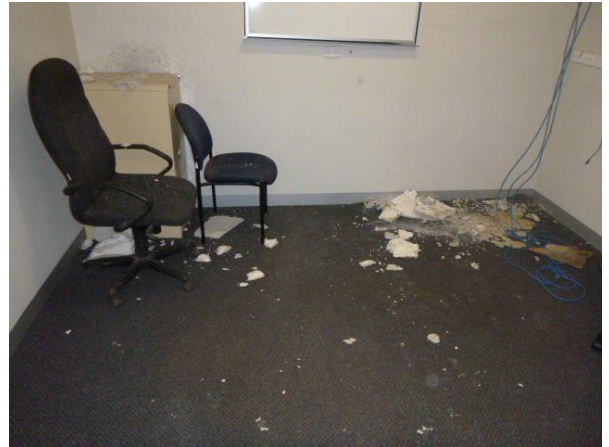
Office 2

From the visible and accessible areas, this area and wall mounted air conditioner appears to be in a serviceable condition for the age of the property. There is water damage to 1 ceiling tile along the north wall that warrant replacing caused from overflowing box gutter.

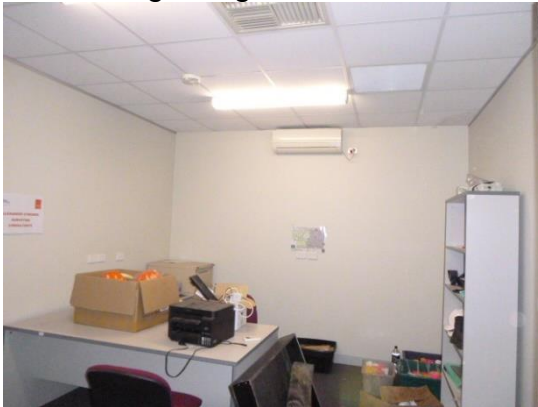
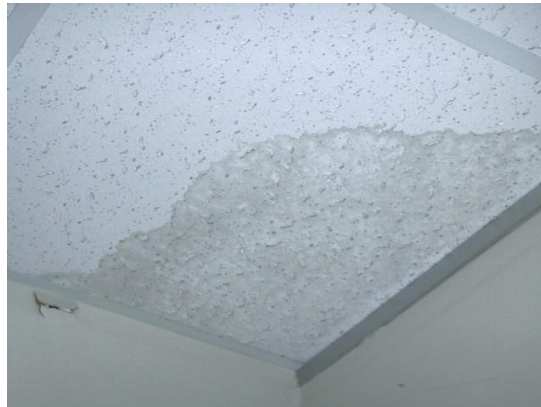
Office 3

From the visible and accessible areas, this area and wall mounted air conditioner appears to be in a serviceable condition for the age of the property. There is water damage to 1 ceiling tile along the north wall that warrant replacing caused from overflowing box gutter.

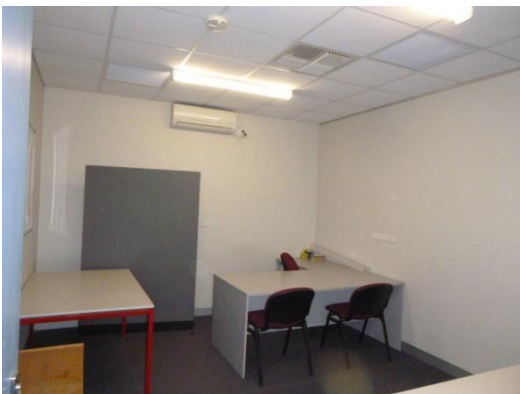
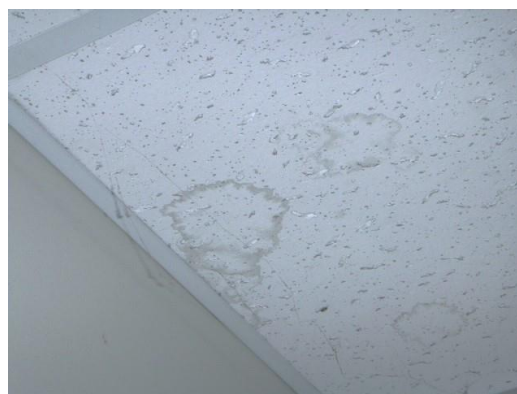
Office 4

From the visible and accessible areas, this area and wall mounted air conditioner appears to be in a serviceable condition for the age of the property. There is water damage to 1 ceiling tile along the north wall that warrant replacing caused from overflowing box gutter.

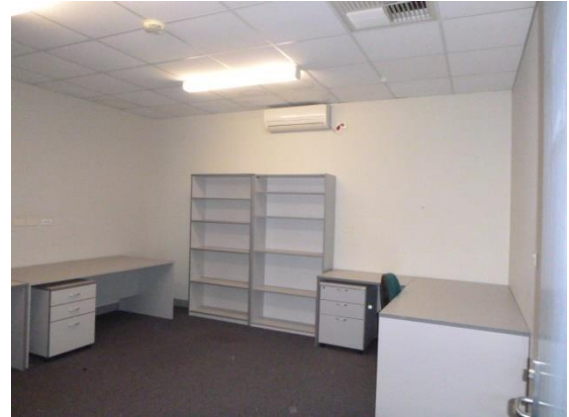
Office 5

From the visible and accessible areas, this area and wall mounted air conditioner appears to be in a serviceable condition for the age of the property.
 There is water damage to 7 ceiling tiles along the north wall that warrant replacing caused from overflowing box gutter.

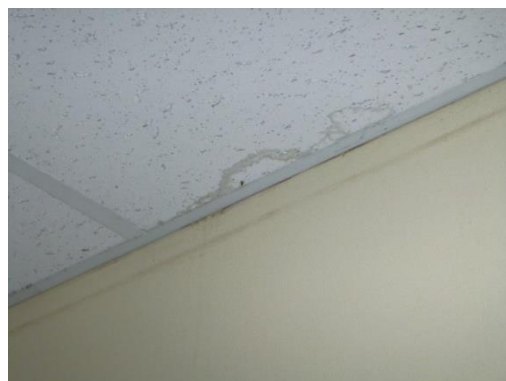
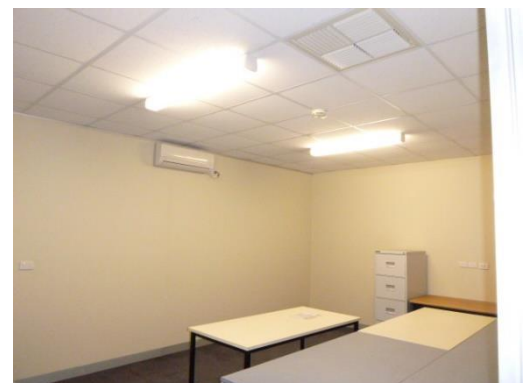
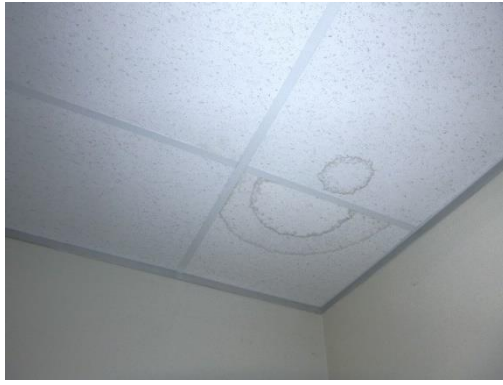
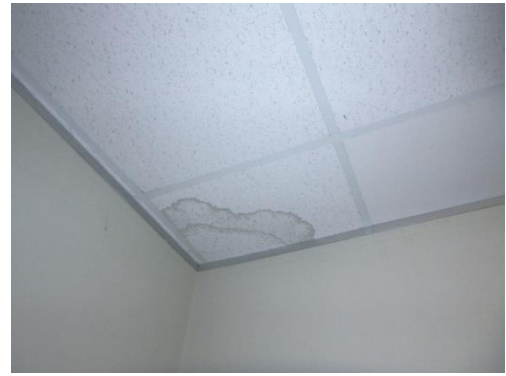
Office 6

From the visible and accessible areas, this area and wall mounted air conditioner appears to be in a serviceable condition for the age of the property.
 There is water damage to 3 ceiling tiles along the north wall that warrant replacing caused from overflowing box gutter.

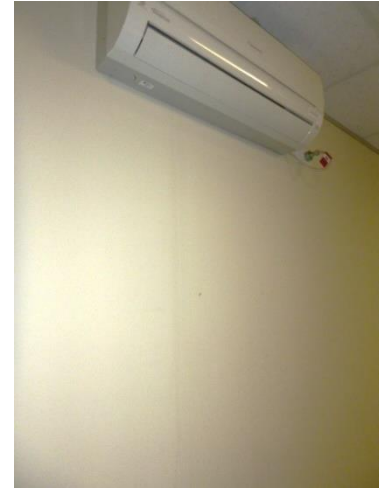
The wall mounted air conditioner is shedding evacuate water down the wall from a poorly mounted connection tube inside the unit. Warrants repair

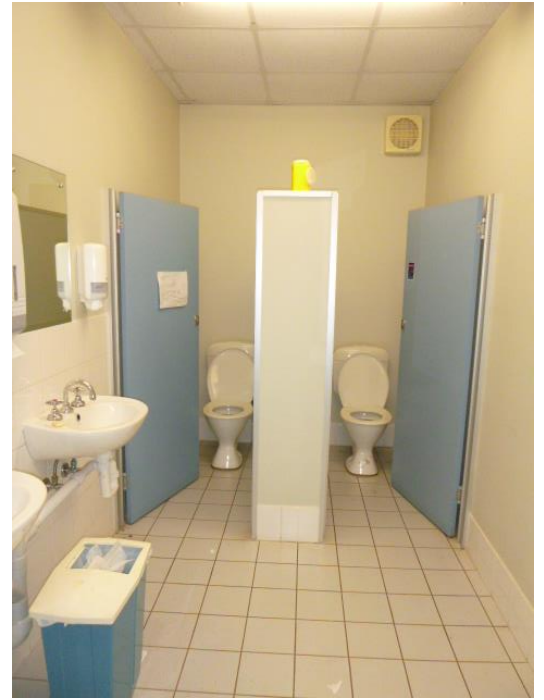
From the visible and accessible areas, this toilet has 2 pans and cisterns and 2 basins. 1 pan and cistern is out of order and not in a serviceable condition Warrants repair.

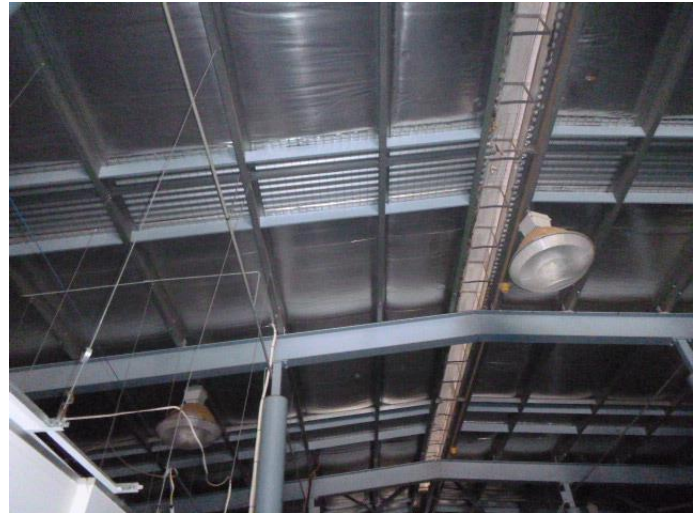
Roof Void Findings**General Disclaimer****Roof Frame Type**

Steel portal frame and light steel perlins.
Structural integrity of the Steel portal frame and components were scrutinized and no defect identified.
