## **Mount Laura Conservation Reserve Works August 2009 to May 2010.**

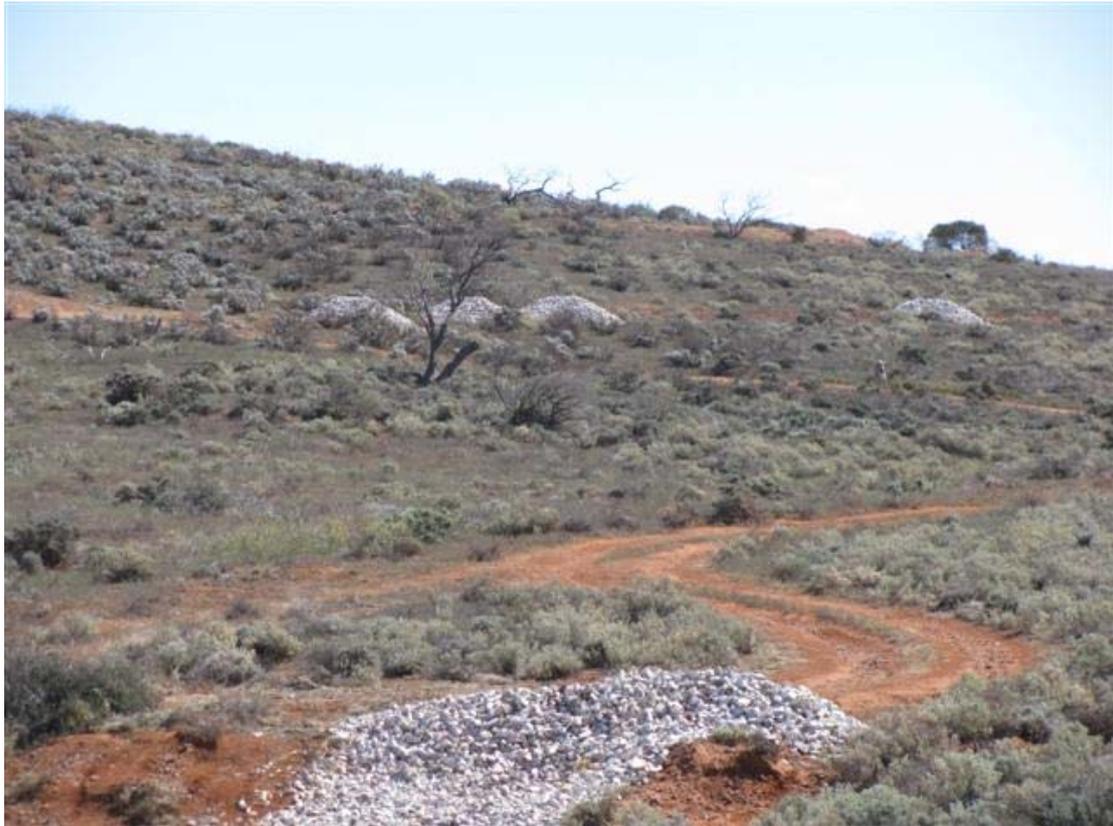
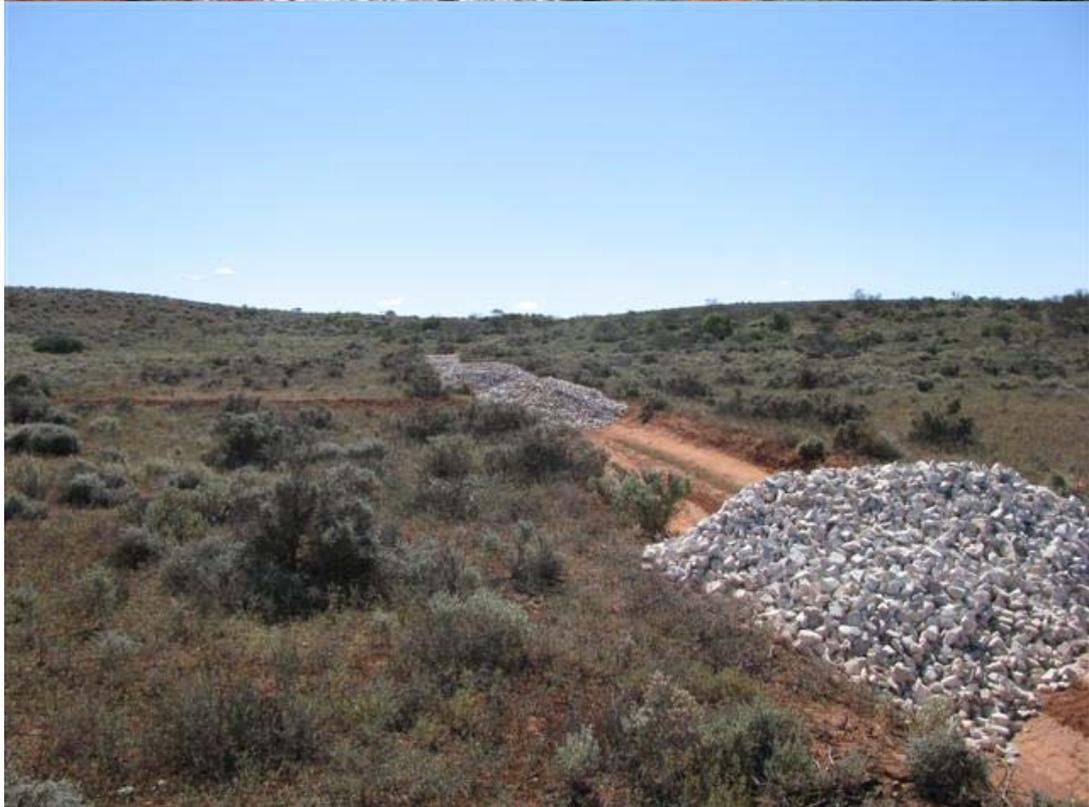
Picture above shows water that used to run down this track, which acts as a drain during heavy rainfall, will now pond behind these piles of ballast, and finally 'bleed out' into the surrounding vegetation.
