19.1.1 Unsolicited Proposal – 127 Nicolson Avenue – **CONFIDENTIAL**

Council Meeting: 15 May 2023
Author's Title: Manager Finance **File No.:** 0-159
Directorate: Corporate Services

A – Valuation
B – Formal Counteroffer
C – Building Report

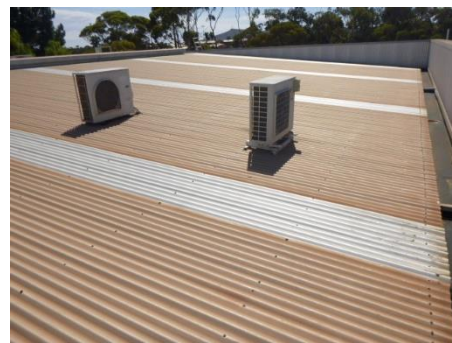
Roof sheet Fixings

Satisfactory

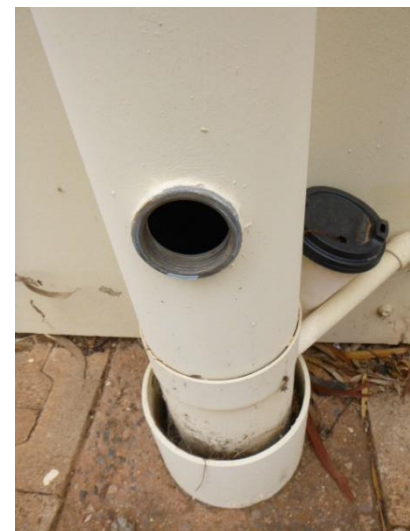
All downpipes at their base have a port to facilitate cleaning. Normally the caps would be in place but in this case all caps have been removed.

This may be the result of metal theft or the stormwater drains blocked. Warrants having all stormwater drains connecting downpipes inspected for blockages and receiving all clear notification and plastic caps installed.

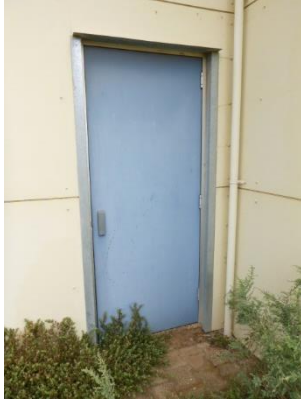
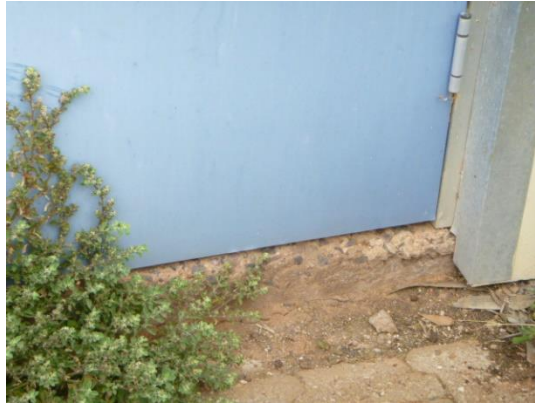
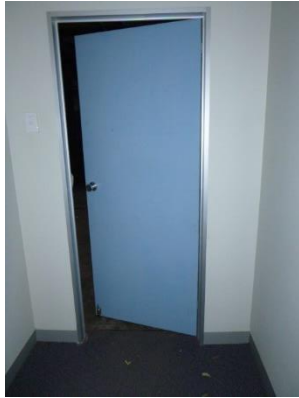
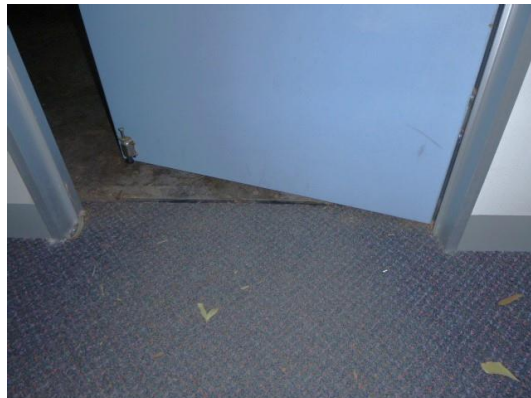
External Doors

2 External doors have no weather seal to keep rainwater from entering beneath the door.
Warrants installation of a raven seals.

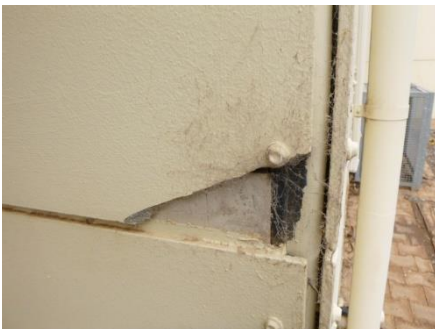
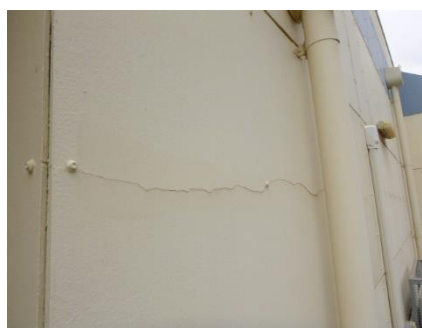
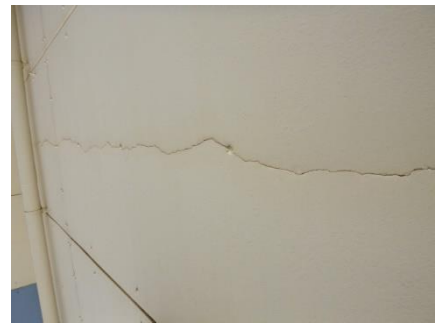
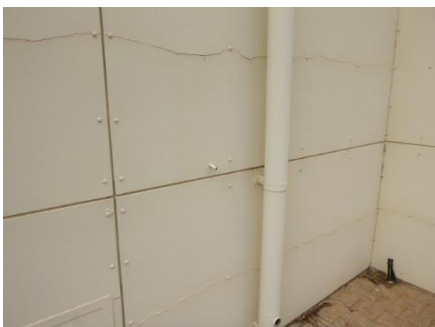
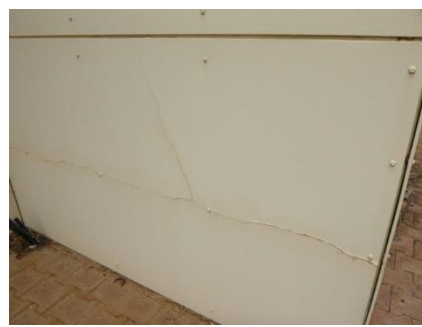
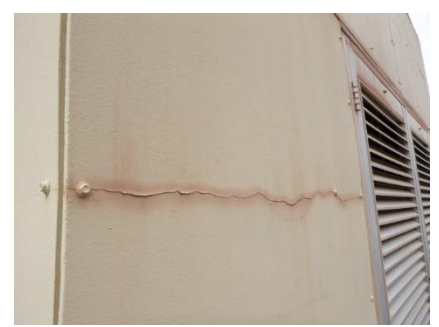
Exterior Wall Material

Commercial grade cement sheeting has thermal damage cracks through, across and around approximately 20% of the external wall cladding.

Cement sheeting damage warrants flushing and painting.

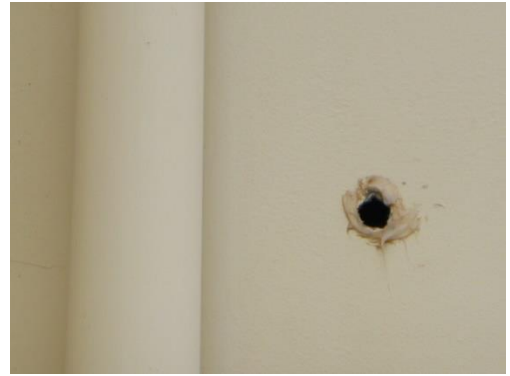
There is a hole to the north facing cladding that warrants flushing and sheet panel painted.

6 Exterior cladding cement sheeting panels require replacing to avoid rain water entry

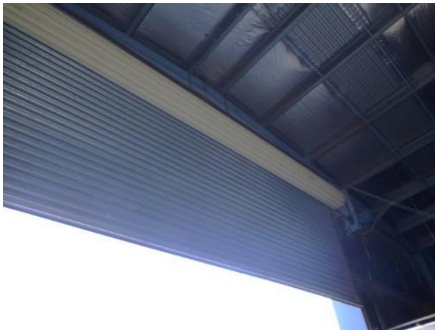
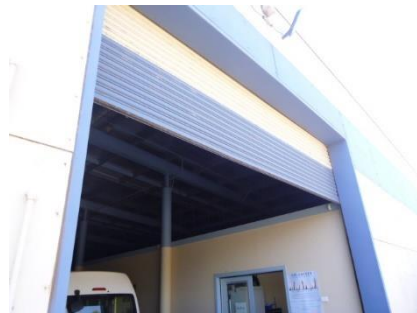
Storm water issue

Immediately outside the roller door is a bitumen infill that will direct rainwater traversing the driveway surface and running down the face of the roller door to enter the building.

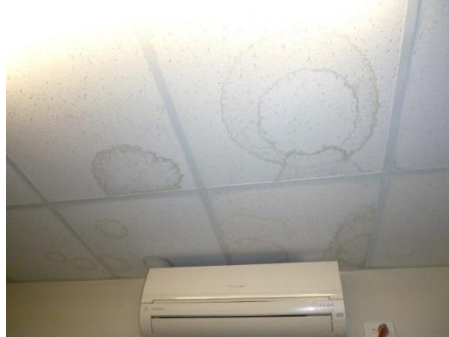
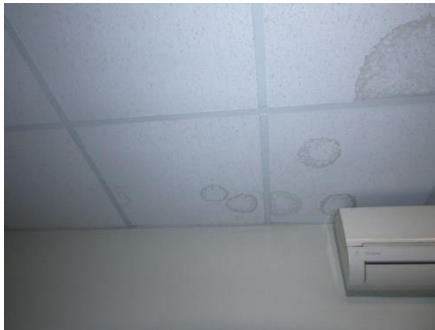
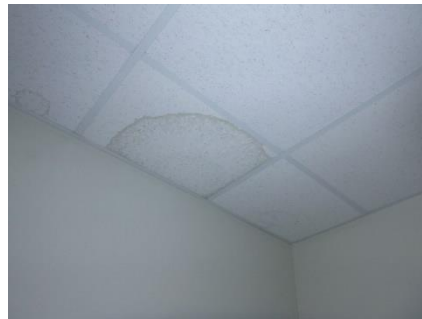
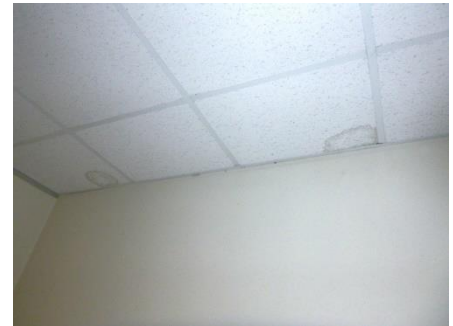
From the visible and accessible areas, this area and wall mounted air conditioner appears to be in a serviceable condition for the age of the property.
 There is water damage to 7 ceiling tiles along the north wall that warrant replacing caused from overflowing box gutter.

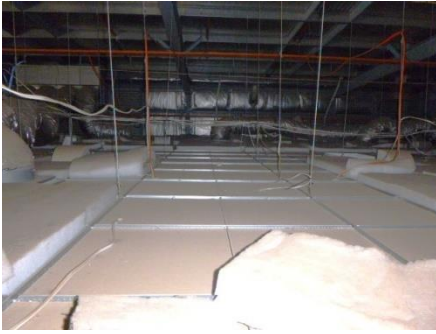
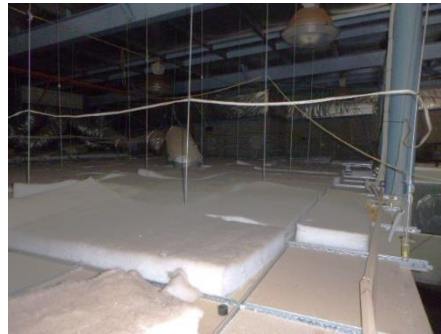
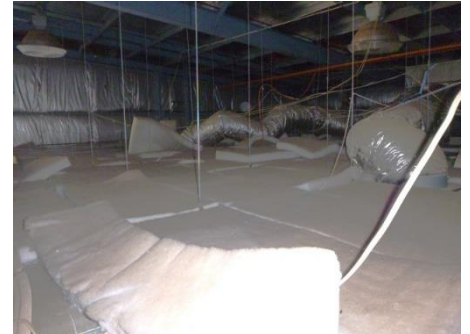
R2.5 Insulation batts cover approximately 30% of the ceiling

Appears most of the existing insulation batts have blown away/missing

Existing energy efficiency is lost due to missing ceiling insulation causing air conditioners to work at peak capacity shortening the coolant and air conditioning units life span.

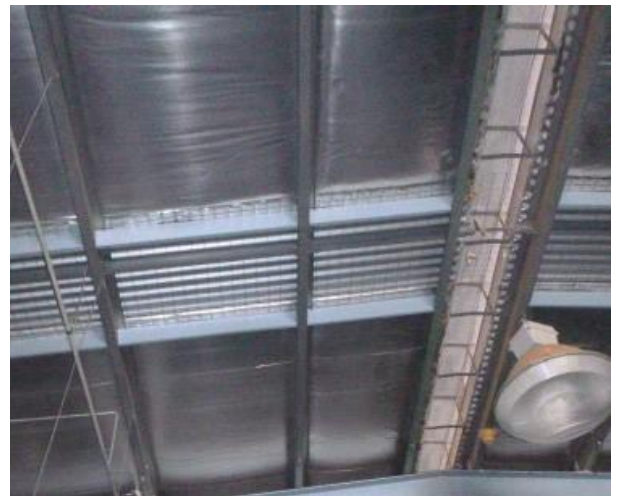
R0.8 Sisalation is installed beneath the roofing iron

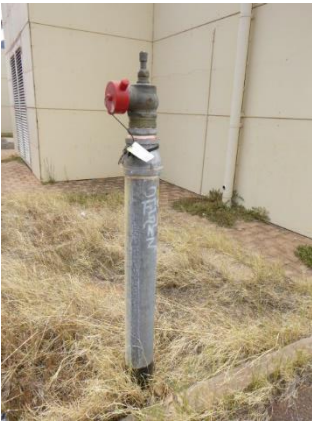
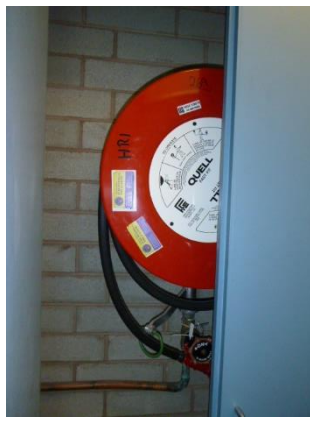
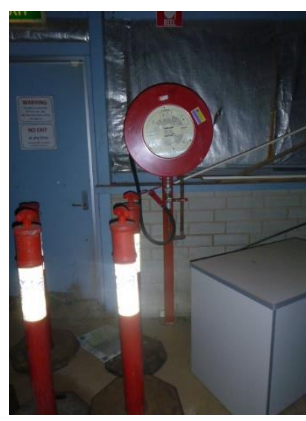
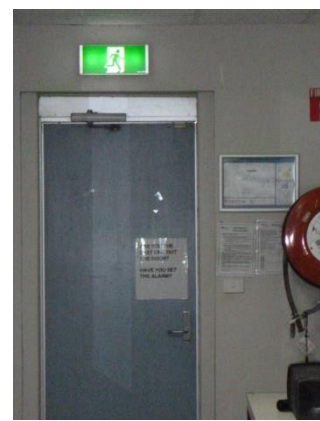
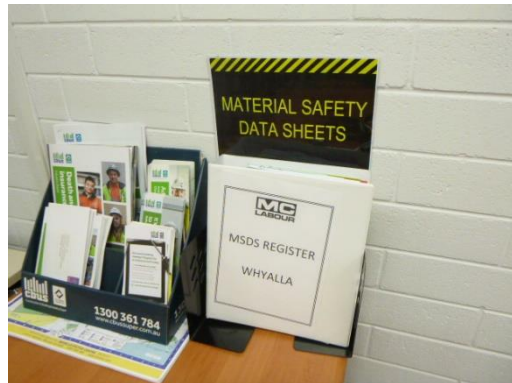
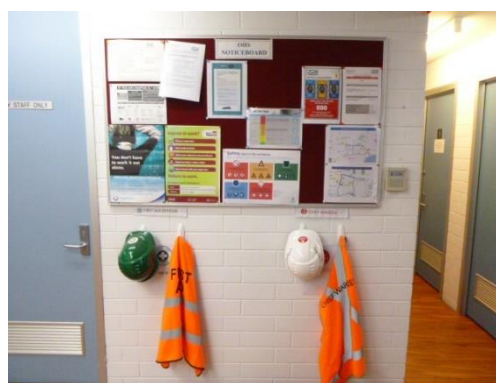
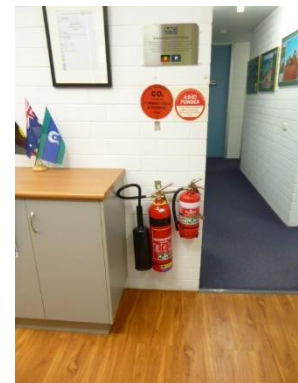
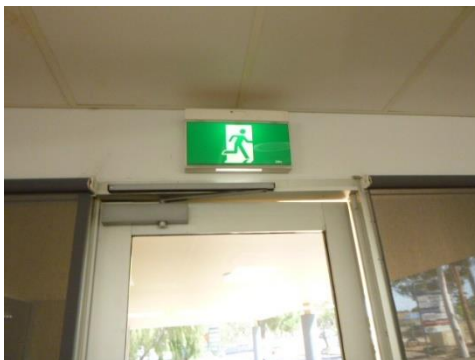
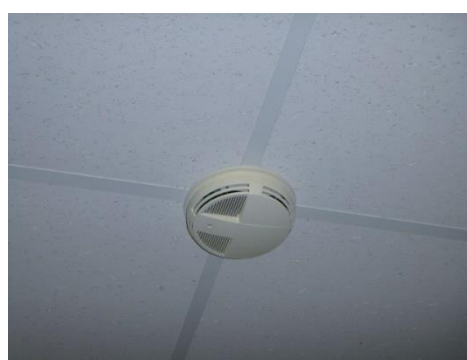
NOTE:

Essential Safety Measures requirements satisfied
